Historic Lighthouse Preservation Handbook

1997

Introduction

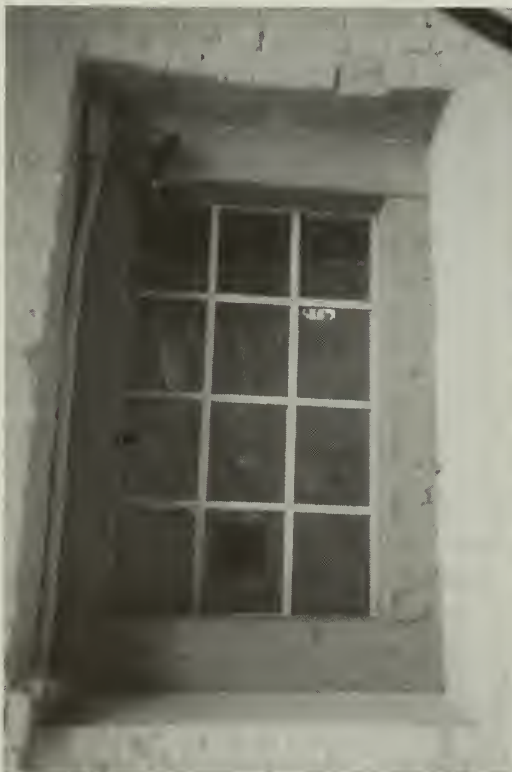
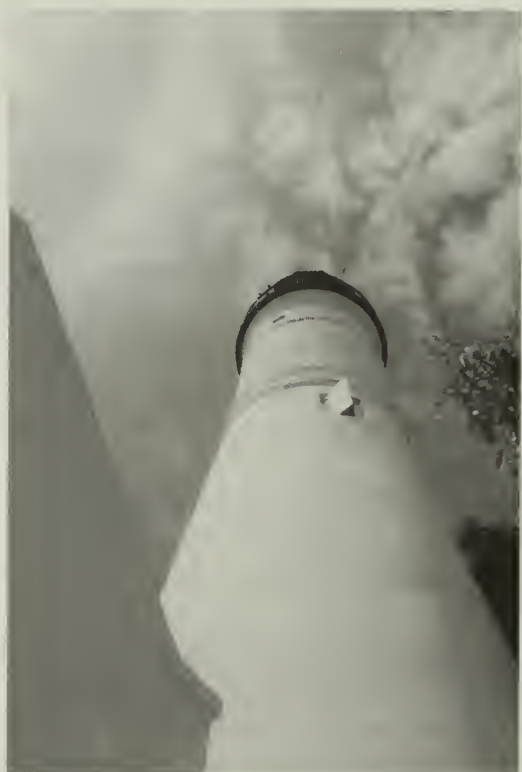
Figures 2 through 5 illustrate successful replacement window designs. These solutions can be easily adapted to most historic lighthouse window designs. During the rehabilitation of the lighthouse shown in Figures 2 and 3, the metal multiple-light windows were reproduced based on the remnants of the original windows and on historic lighthouse construction documents from a lighthouse built in the same region during the same time period. During the restoration of the window opening, the granite window frame was also replicated from remnants found in another window opening. Even the tooling pattern on the stone surface was reproduced. A single-leaf, vertical-plank shutter can be seen on the lighthouse in Figure 3. This detail was also based on existing evidence. Not only is this detail historically accurate, but it has protected the lighthouse during hurricane-force winds.

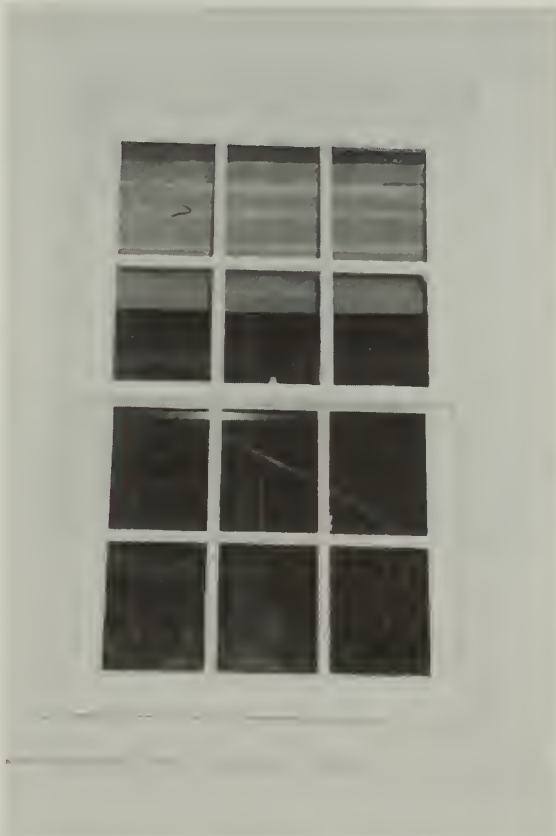
Figure 4.

The wooden, double-hung, six-over-six window were reproduced from historic photographs. Subtle details such as molding profiles and hardware that could not be determined from historic photographs were based on lighthouses constructed by the same builder during the same time period. Figure 4 shows a close-up of the exterior side of the window; note the simple detailing and lack of profiled trim. These characteristics are typical of lighthouses constructed before the Civil War. Figure 5 shows the lighthouse after the installation of the replacement windows.

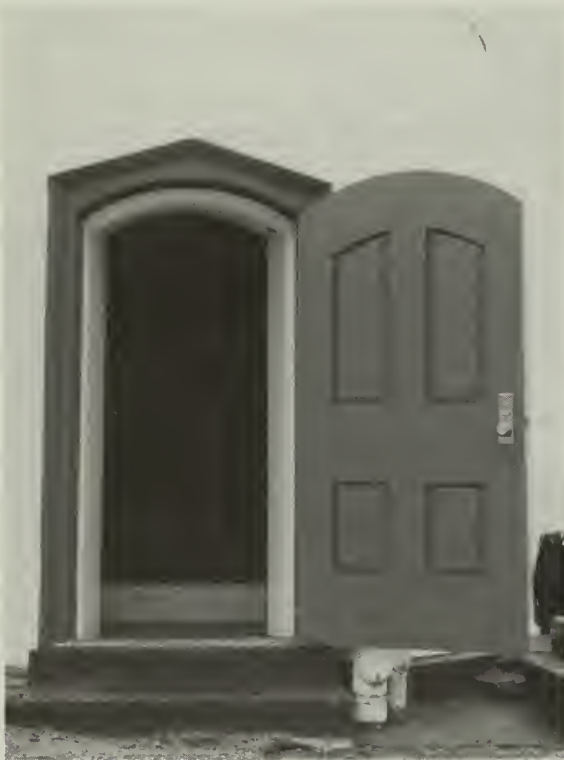
Figure 6.

Figures 6 through 9 are examples of successful replacement door designs. The solutions displayed here can be easily adapted to most historic lighthouse door designs. The wood replacement door design in Figure 6 was based on wood-frame and panel-construction-style doors commonly used when this lighthouse was constructed in 1928. The only difference made to the c. 1928 design was the upgrade of the hardware to stainless steel components. This door design was based on information from historic photographs from the U.S. Coast Guard archives and

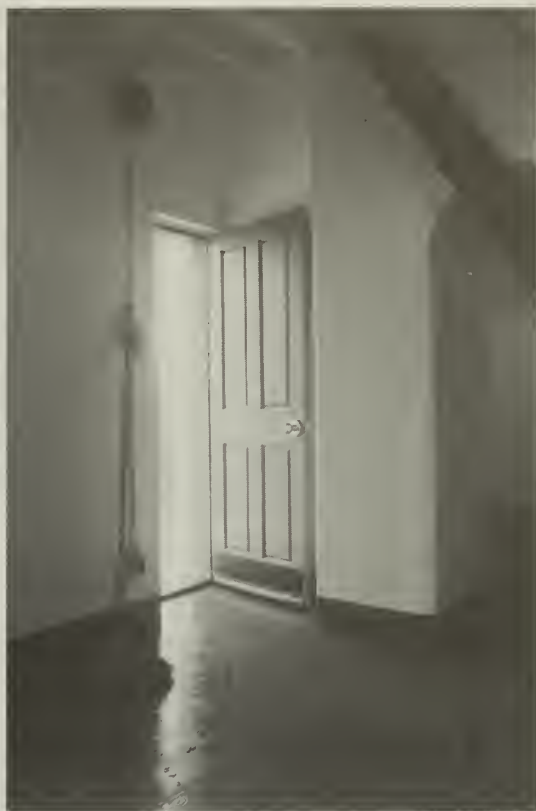
Figure 8.

Wood frame and panel door: Partial remains of a wood frame and raised panel was found inside the structure during rehabilitation. This evidence was used in conjunction with historic construction drawings to develop this design. The door shown in Figure 8 was made by a local mill from Douglas fir. The hardware is all stainless steel to minimize maintenance and to extend the serviceable life of the door. As an added weather protection measure, a traditional drip edge has been installed along the bottom of the door to shed water away from the door opening.

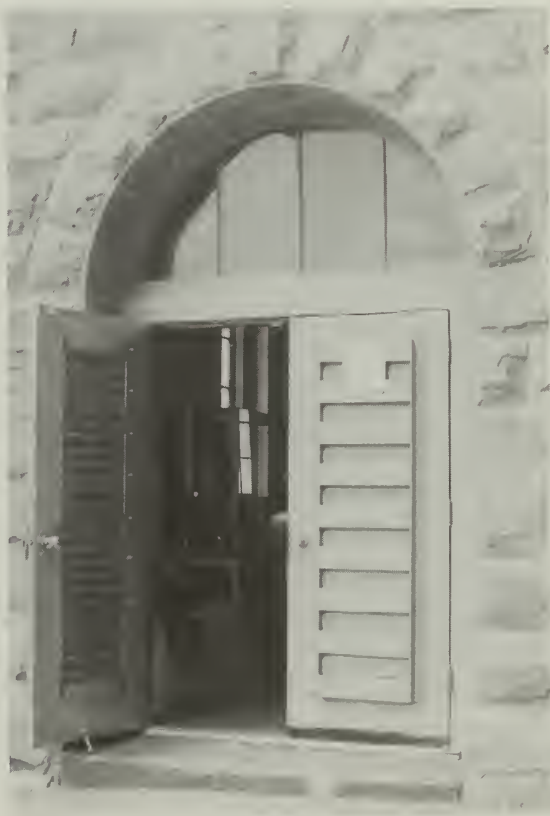
Figure 9.

The door in Figure 9 is designed to minimize the problems at a lighthouse that does not see regular visitation because of its remote location. Four factors took precedence over historical correctness: weathertightness, ventilation, security, and maintenance. The door had

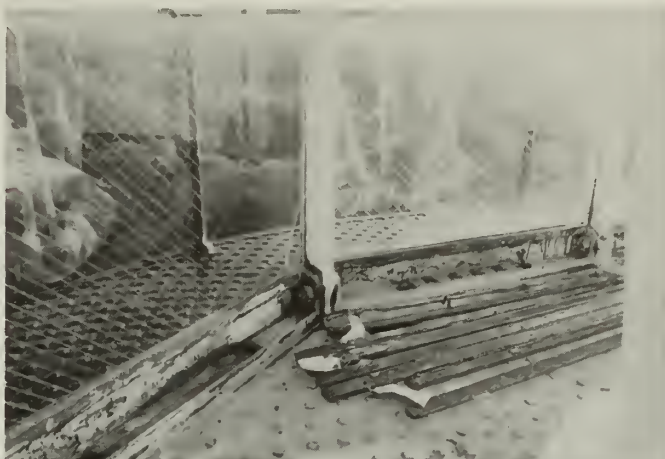
Figure 10. Oblique of the interior of the lantern room with exterior bronze astragals stored in the foreground before cleaning and removal of the extent wire-glass panels.

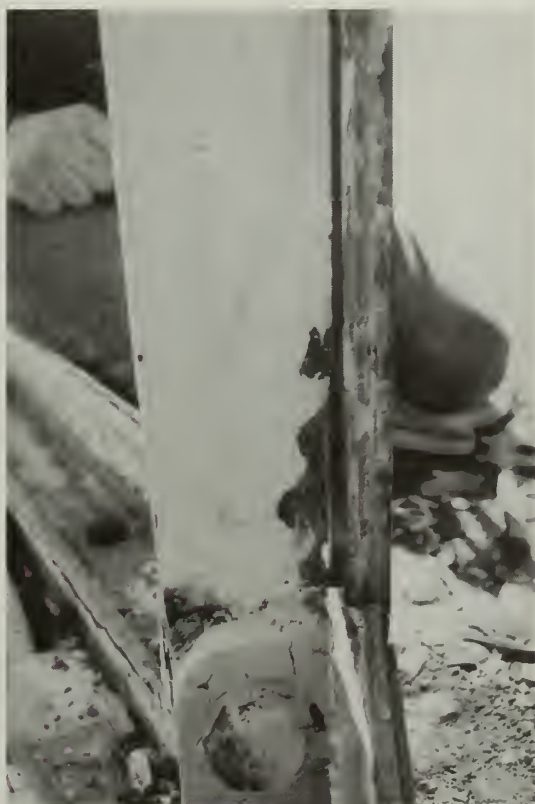
Figure 11. The extent of the damage to the cast-iron column through exfoliation can be seen in profile after the removal of loose rust and the lower bronze mullion.

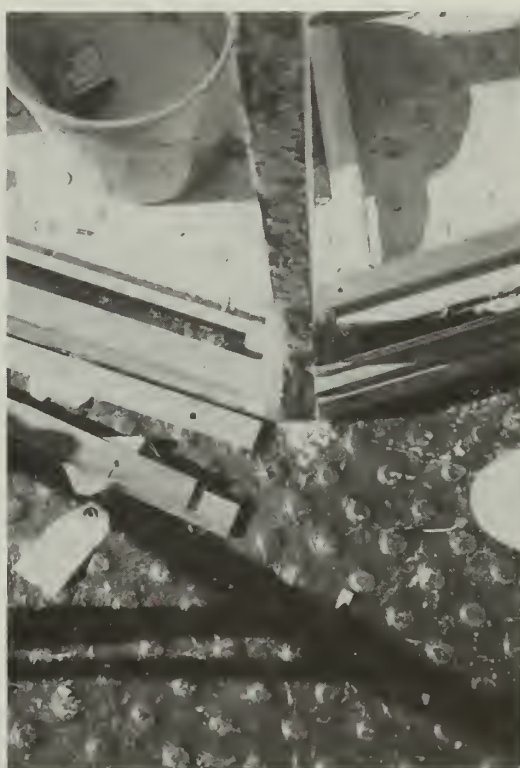
Figure 12. Detail of the bronze sill when the lower mullion is removed; the fastener is re-tapped and the cast-iron column is treated with a rust converter. Note that the bronze astragals have been cleaned and are ready to accept the glazing system.

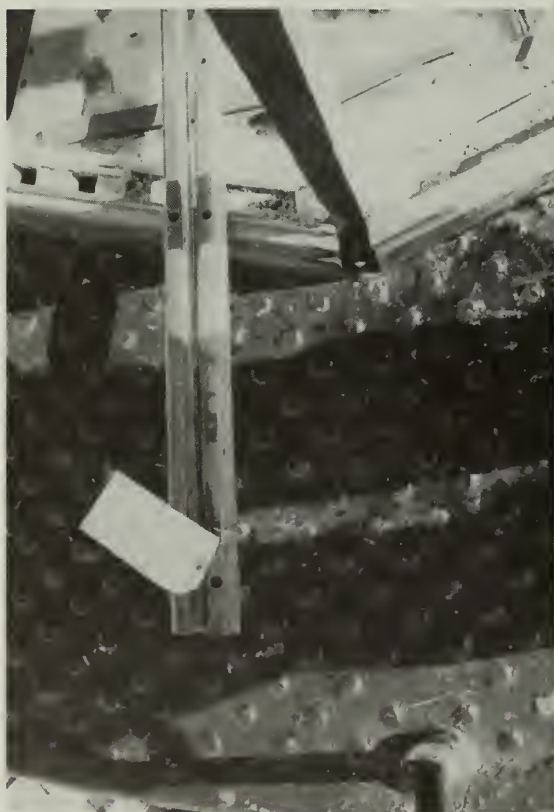
Figure 13. This detail of the bronze sill shows the location of the new lower fastener before its removal and resetting with the lower bronze mullion.

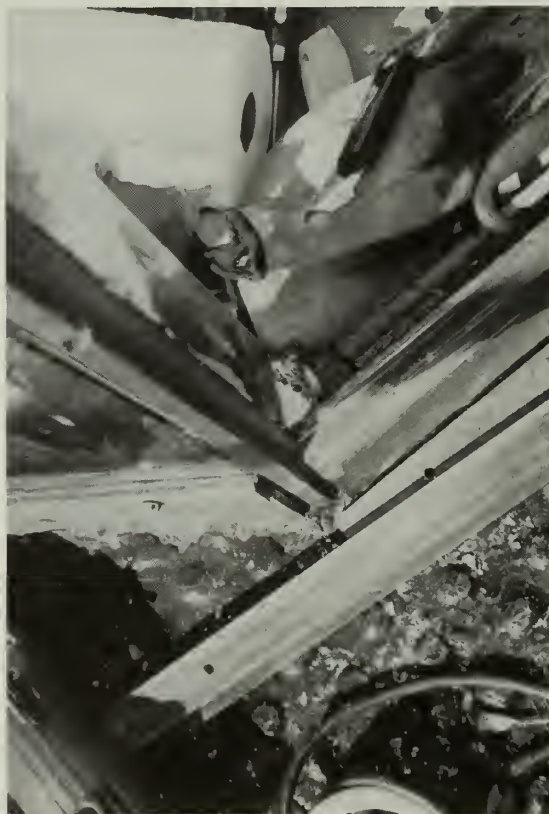
Figure 14. Following placement of the restored bronze mullion, the fenestration is ready to receive the new glazing system.

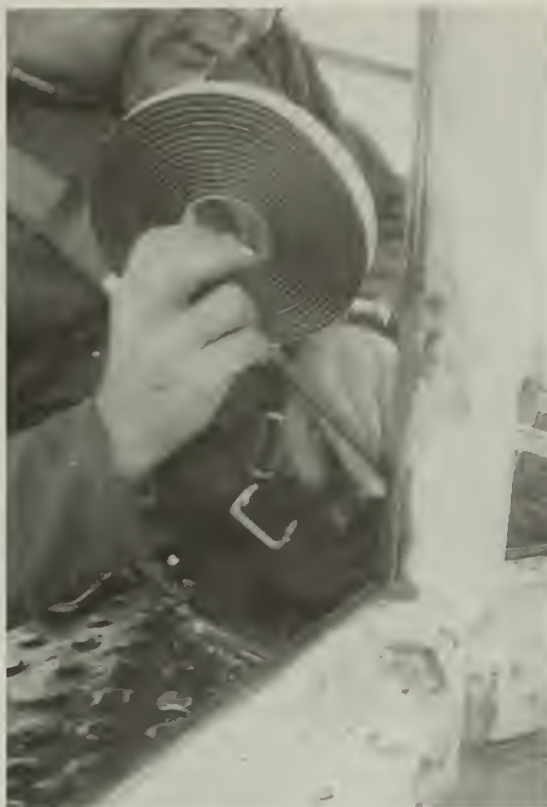
Figure 15. The polybutyl sealant tape was placed on all receiving surfaces on the plane of the interior face of the glass and on the inside faces of the exterior astragals.

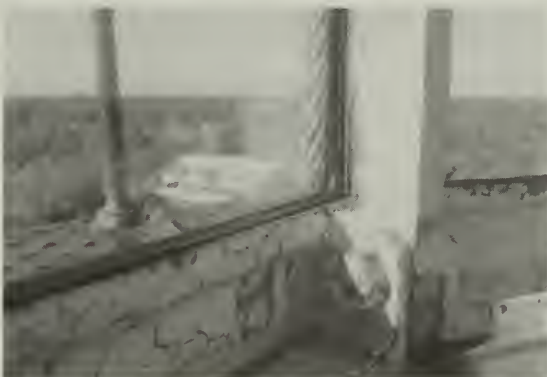
Figure 16. This detail shows the new glazing system in place with associated cast-iron post and bronze sill available to receive additional cleaning and paint removal.

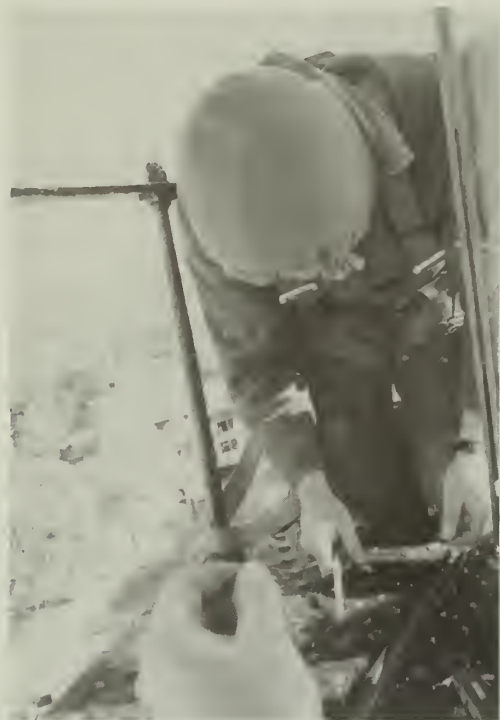
Figure 17. Note the detailing of the finished exterior astragal in place and the polybutyl sealant tape visible in profile.

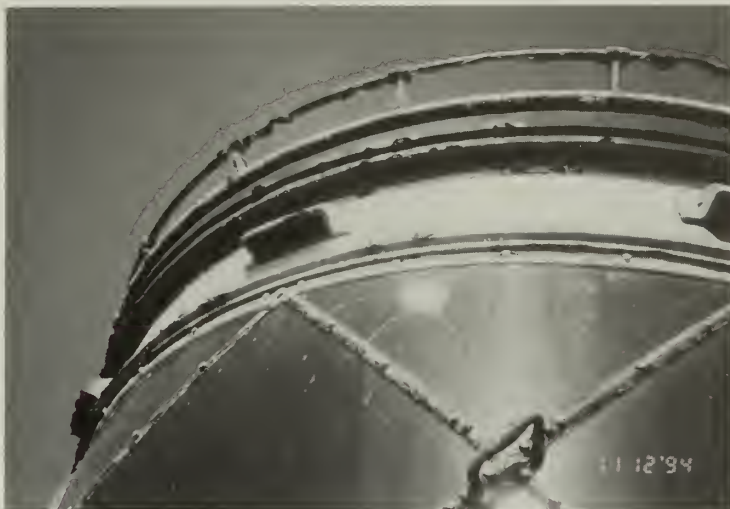
Figure 18. Close-up of the deteriorated conditions of the Anacapa Island Lighthouse before rehabilitation.

Civil Engineering Unit Oakland's Facility Inspection Team originally identified the need for this rehabilitation during an inspection of the lighthouse in 1992. The entire lighthouse was in such poor condition that it was labeled the worst lighthouse on the West Coast (see Figure 18). The inspection team initiated the paperwork that identified both the need for the rehabilitation and funds. Although most large Coast Guard projects normally take five years before being funded, Anacapa was in such poor condition that it was given a high priority; design work started within two years. In late 1994 the architect assigned to the project made his first site visit. The architect determined that the best way to repair the badly deteriorated cast-iron lantern house was to remove it from the concrete tower via heavy-lift helicopter and transport it to the mainland for overhaul. Further investigation, however, disclosed several insurmountable obstacles; he was forced to consider a more conventional but far from easy onsite rehabilitation of the entire lighthouse. The following scope of work was identified and budgeted for \$325,000:

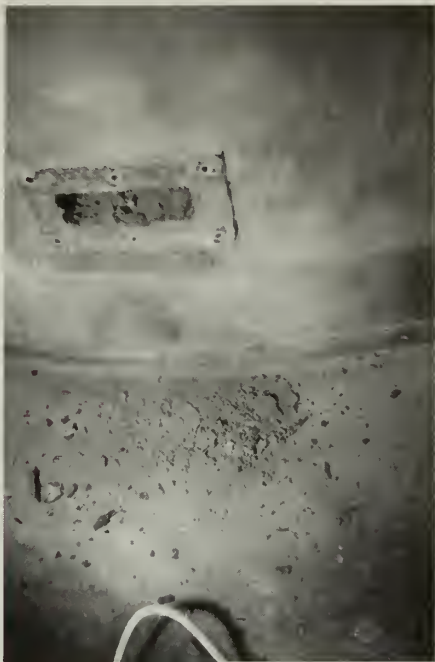
Figure 19 (left). Buildup of rust in parapet wall vents.

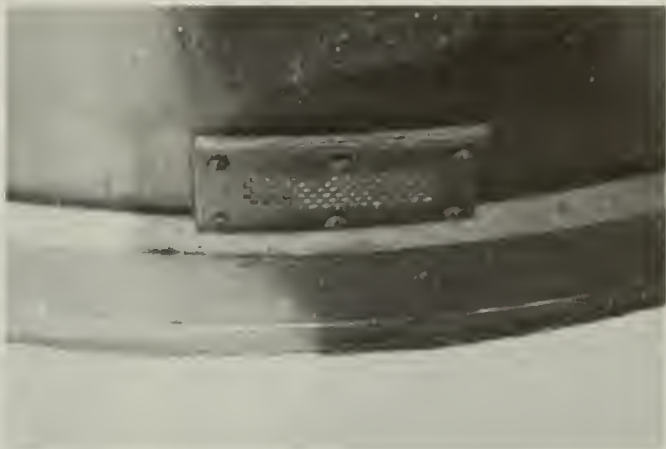
Figure 20 (above). The finished vent installation: 15-lb. roofing felt was placed between the bronze vent grill and the cast-iron parapet wall.

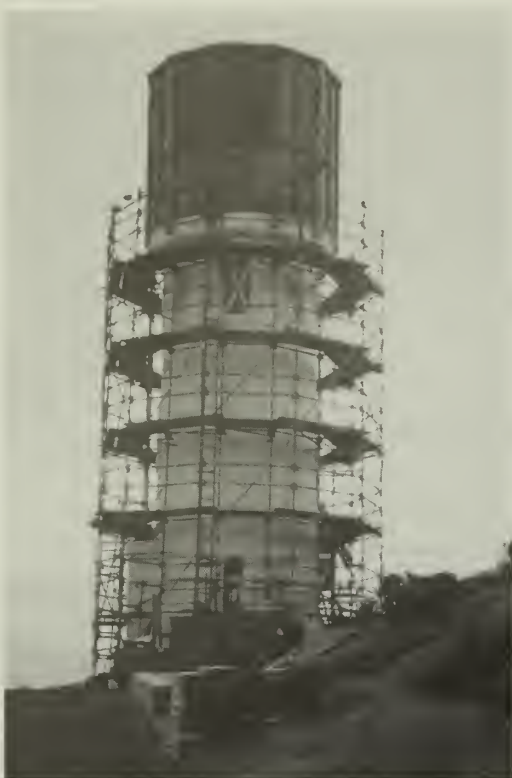
Figure 21. View of the plywood lantern enclosure and scaffolding.

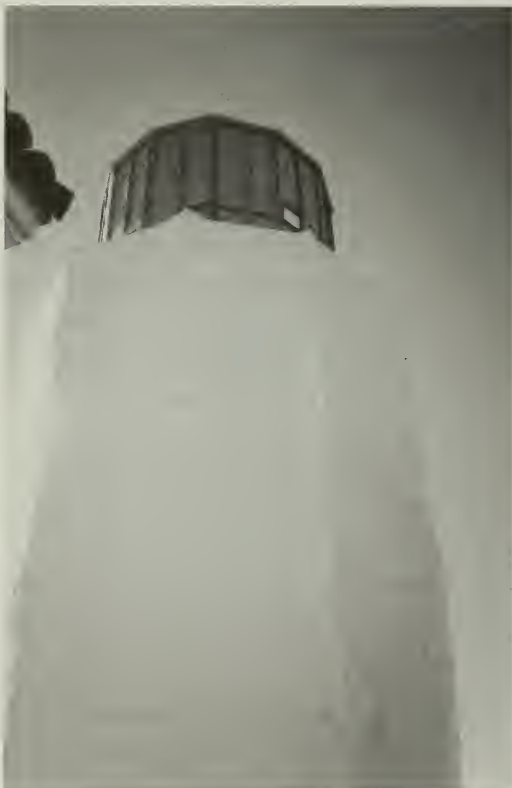
Figure 22. View of the lighthouse scaffolding covered with shrink wrap to contain all hazardous materials and protect workers from severe weather.

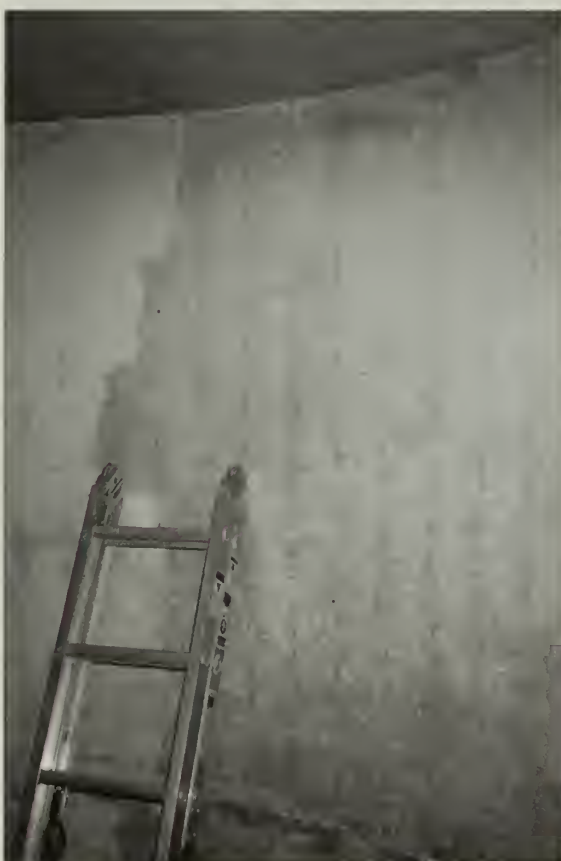
Figure 24. The interior paint was effectively removed using needle gun scalers, without damaging the concrete as evidenced by the visible impressions of the formwork boards.

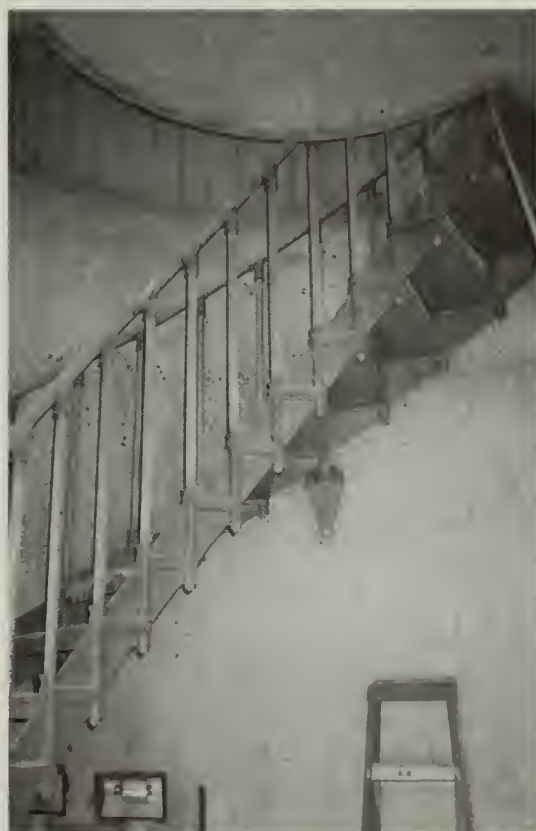
Figure 25. After the cast-iron stairs were blast-cleaned, they were rinsed to remove all traces of lead dust; flash rust immediately formed (as seen in this photo). Before painting, this light rust was removed with wire brushes.

expected and did not pose a problem (see Figure 25). All surfaces were then wire brushed, prepped, and primed by a three-man team who only prepped what they could prime within an hour. Although the primer used was designed for use over flash-rust, we did not want to chance a coating failure.

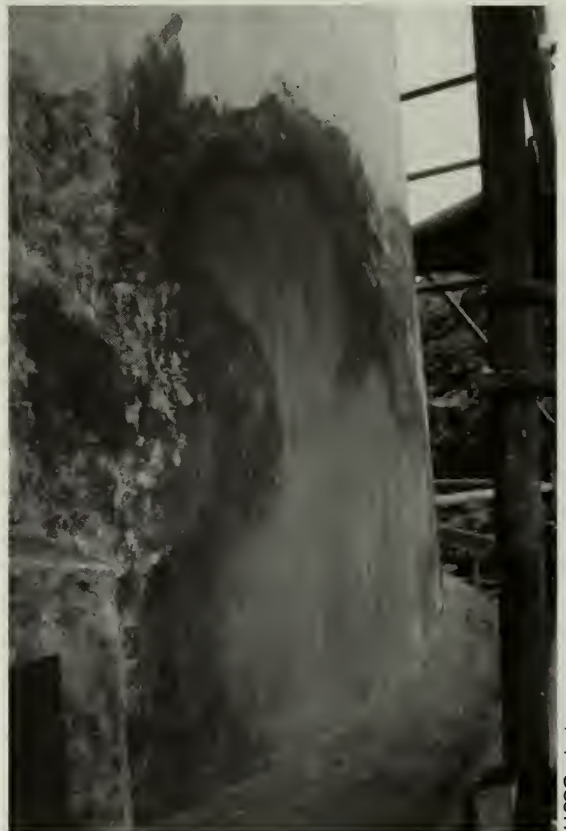
Figure 27. The areas where the loose mortar finish coat was removed were repaired with a two-part mortar patch. The final texture on the patch was tooled to match the historic wall surface. The patch was completely invisible after the tower was painted.

The 3/8-inch white mortar finish coat that had been applied over the exterior concrete when the light was built in 1932 was not identified in any of the original drawings. As a result, no one looked during the work site visit for signs of delamination. After the scaffolding was in place, however, several areas were found to be loose between the 10- and 30-foot elevations. The foreman became concerned that other unidentified delaminated areas would fall out after the job was complete and ruin his work. The foreman inspected the entire tower and found an additional 100 square feet of delaminated mortar. After receiving approval to repair any bad mortar, he personally chipped away all the loose mortar and applied a two-part masonry patch material. The repair work was of such high quality that the patches were unnoticeable when the tower was repainted (see Figures 26 and 27).

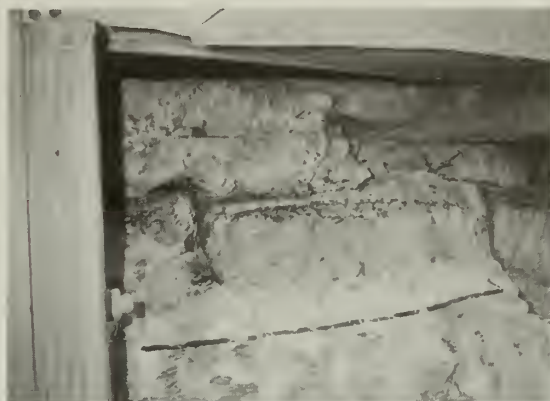
Figure 28. Close-up of the damaged concrete gallery deck after the loose concrete has been removed and before the damaged concrete was repaired using pressure-injected epoxy grout.

One major area of concern was the concrete gallery deck located outside the lantern. This deck had considerable damage in two areas without any evidence of the cause. The outer rebar showed signs of corrosion but the damage went 18 to 24 inches deeper into the concrete. Since freezing was not an issue, the cause of the damage was at first unknown. Closer examination revealed signs of an explosion inside the concrete, and we noticed bolt patterns for two old antenna mounts directly above the area. We determined lightning to be the cause. There was no practical way to dig out the

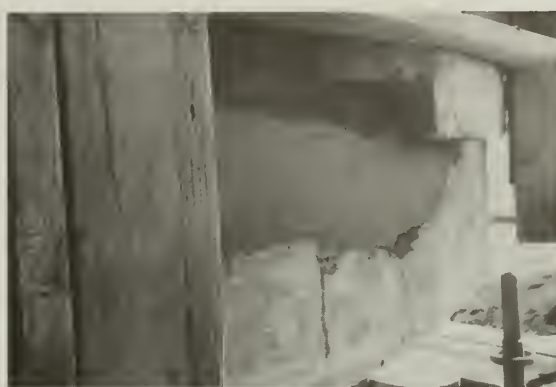
Figure 29. The first application of the mortar patch material to the damaged concrete.

broken concrete; the project was already over budget. We decided to do a pressurized epoxy injection and fill all the voids. The area was prepped and pumped full. The outer three inches were left unfilled so the two-part mortar patching compound could be used to restore the damaged area (see Figures 29 and 30).

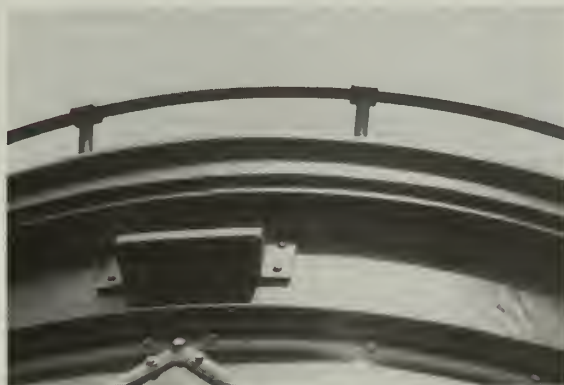
Figure 31. Close-up of the finished metal work on the lantern.

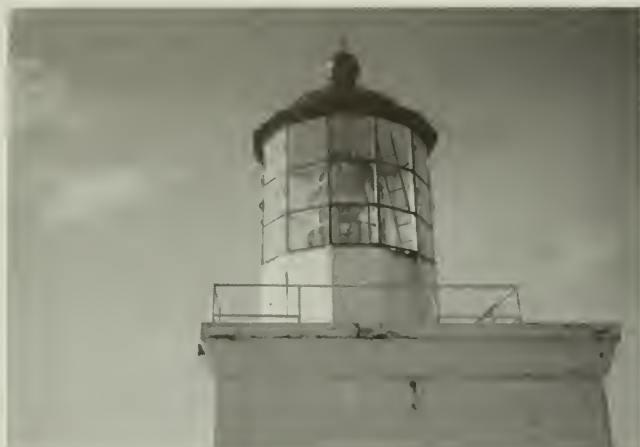
Figure 33. Point Bonita Lighthouse before rehabilitation; note missing gallery deck and holes below between the bottom of the lantern glass and top of the service room wall.

The poor condition of Point Bonita was first noted by the Officer in Charge of the San Francisco Aids to Navigation Team (ANT). His request prompted a site visit to Point Bonita in January 1993 to conduct a facility assessment and provide advice on how to repair the structure (see Figure 33). The original plan was to stop the water from entering the lighthouse and let Civil Engineering Unit (CEU) Oakland do the overall renovation in a couple years. But further investigation indicated the need for more immediate repairs, using self help-funding and the ANT personnel. The project soon grew into a full renovation that took six months and \$75,000 to complete.

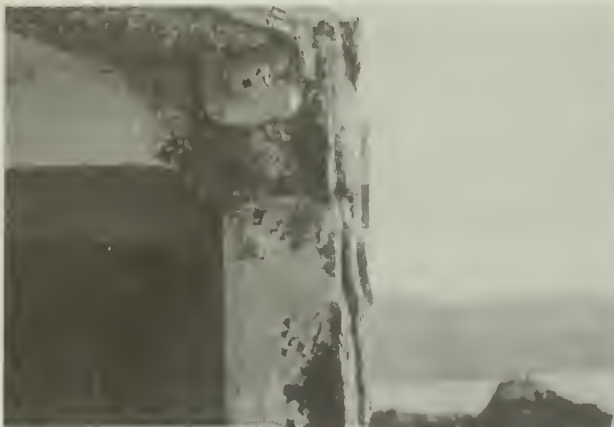
Figure 34. Close-up showing what remained after the gallery deck brackets were cut off with a torch. Note the heavy rust and paint failure caused by exposure.

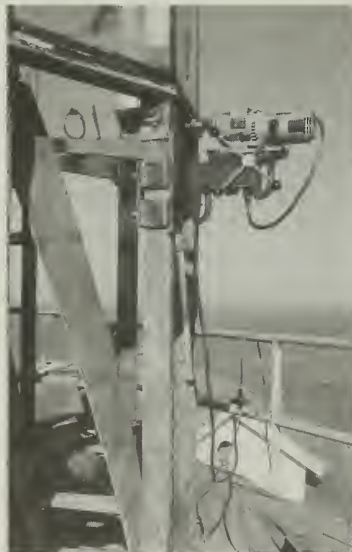
Figure 35. Jig used to bore holes in the gallery bracket tenons.

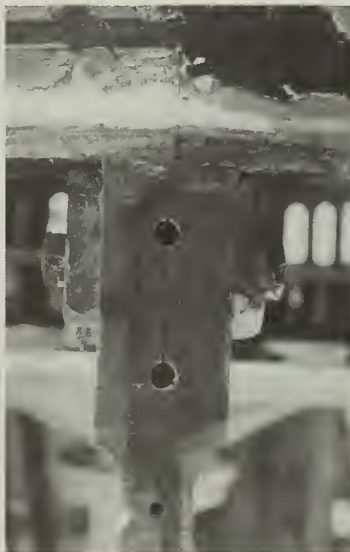
Figure 36. View of the gallery bracket tenons after the holes have been drilled. The tenon on the right connected to the exterior gallery; the tenon on the left is part of the interior gallery deck bracket. The 'v' that has been stamped in the end of the left tenon is an assembly identification mark.

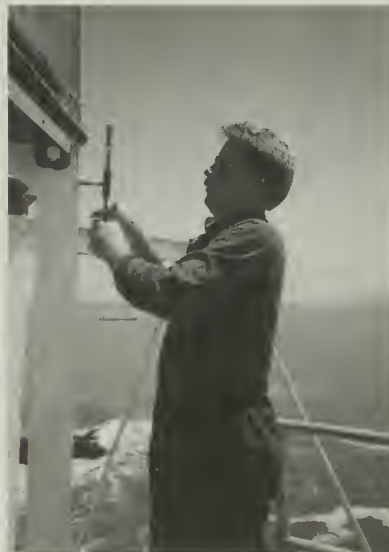
Figure 37. After drilling, threads were cut into each hole using a hand-operated tap.

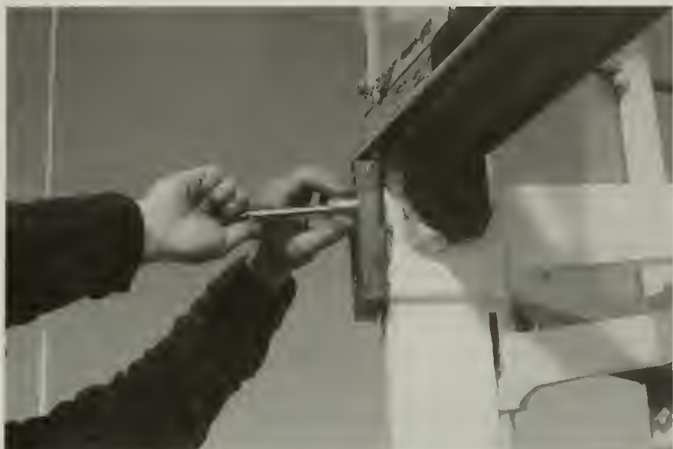
Figure 38. To provide a plumb mounting surface for the gallery deck, each mounting surface was covered with Belzona (a two-part metal paste); then the mounting plates were installed and tightened until they were plumb. The excess Belzona can be seen oozing near the middle of the plate.

Investigative demolition followed. The original gallery deck had been removed in the 1960s, but no details were available on how it was performed. First removed was the fiberglass cloth that sealed the watchroom panels to the lantern room and covered the areas of the original gallery deck brackets. Fortunately, the old brackets had been cut off above the wide base flange with a torch, leaving the tenons from the original brackets intact inside the cast-iron lantern frame (see Figures 34 and 36). Removal of the remaining tenons from the frame and fabrication of new gallery deck brackets duplicating the originals proved impractical because the tenons were rusted tight and pinned in place. The tenon was therefore used as an anchor. The old base flange flush with the frame was cut using a portable metal-cutting bandsaw and the area ground flush. A special jig was designed for the magnetic drill press; two holes were then drilled and tapped directly between each set of tenons (see Figures 35, 36, and 37). A one-inch-thick mild steel mounting plate consisting of two recessed bolt holes and four tapped holes was then put in place. (304 S/S might have been an even better choice; the mild steel is holding up well, but may become a maintenance problem if the lighthouse isn't properly maintained.) The two recessed holes allowed the plate to be bolted to the lantern frame and the new bracket bolted directly over the two base bolts. The area beneath the plate was covered with a 1/8-inch layer of Belzona Metal filler to ensure there would be no voids and to act as a leveling compound (see Figure 38). The bolts as well as the plate were covered with a releasing compound (Vaseline)

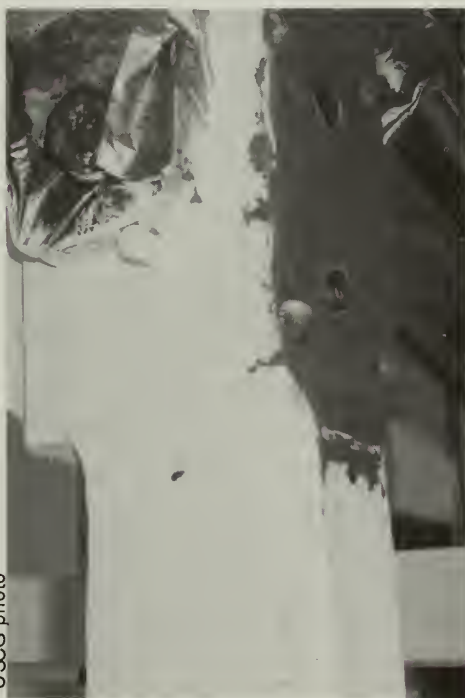
Figure 39 (left). View of the mounting surface after the Belzona had cured and the mounting plate had been removed. The 'knobs' or protrusions on the surface are where the Belzona was squeezed through the holes in the mounting plate. These were ground off along with the excess Belzona that squeezed out around the plate.

and then slowly tightened until the plate was plumb. The Belzona was then allowed to dry before all excess Belzona was ground off (see Figure 39). This procedure worked very well and took no more than three days to accomplish. The base plates were then primed, painted, and caulked before being torqued in place.

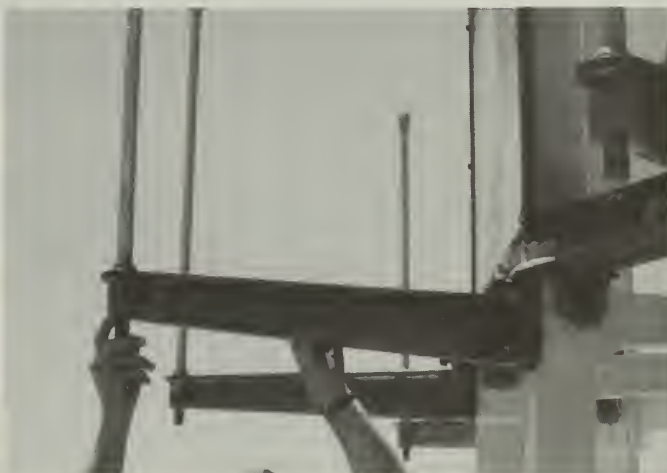
Figure 40 (above). The new gallery deck brackets after installation.

fabricated to match the original cast-iron brackets details. (This is another area where 304 S/S might have been better.) The stanchions were made of 1-inch 304 S/S round stock and 1-inch 316 S/S bolts. The bolts had a 1-inch diameter and 1/4-inch-deep recess machined in the head to ensure the bolts were properly aligned during welding. Custom 1-inch 316 S/S acorn nuts were then purchased to secure the stanchion to the brackets and the handrails. With the brackets and stanchions in place, the 3/8-inch flat bar handrails were then drilled, scribed, and fitted (see Figure 40).

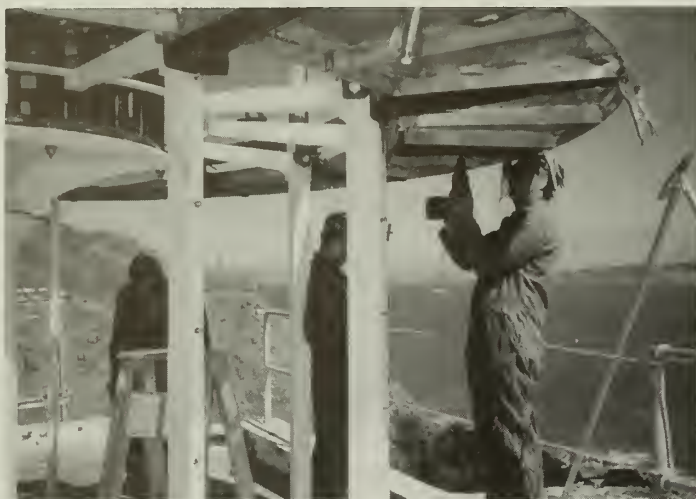
Figure 41. Final fitting and installation of the new aluminum deck plate.

with no signs of dissimilar metals reacting. S/S diamond plate, might however, avoid any future problems (see Figure 41).)

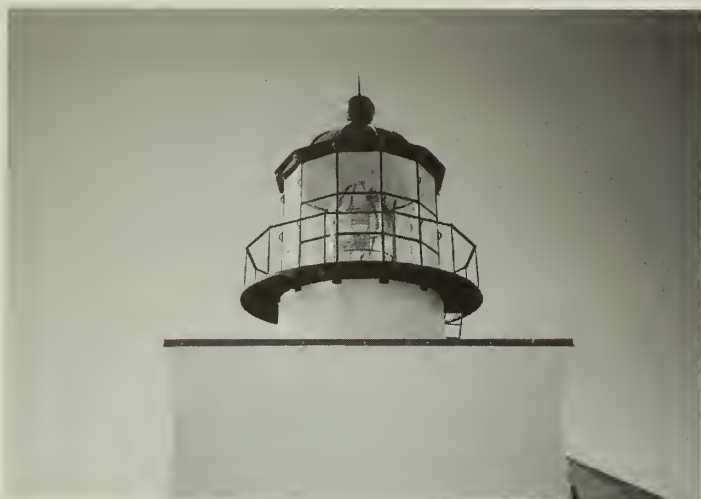
Figure 42. View of the Point Bonita Lighthouse after the gallery deck replacement.

on lighthouses understands dissimilar metals or even how to ensure that materials are properly reinstalled (see Figure 42).

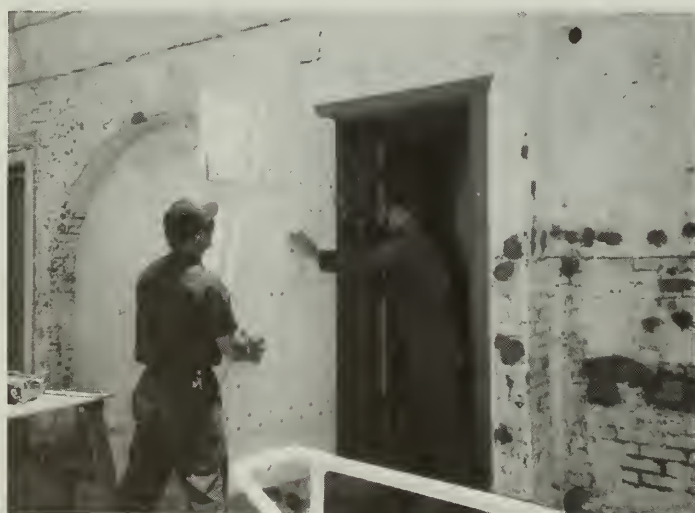
Figure 43. Installation of the new exterior wood storm door.

The exterior storm doors were also easy to duplicate. The pictures were clear and showed one door open and one closed. Both exterior doors were made of 1- by 6-inch tongue-and-groove redwood and fastened together using S/S carriage bolts, nuts, and washers. After the doors were test fitted, they were disassembled, primed, painted, and reassembled. These doors have held up extremely well and have given no trouble (see Figure 43).

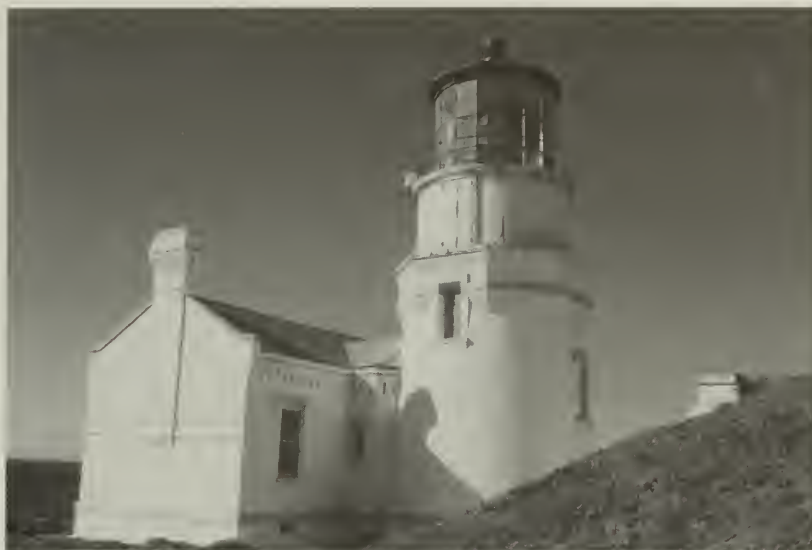
Figure 44. *Before the rehabilitation.* Note the doors at the watch room. A new louvered panel will be installed for added ventilation.

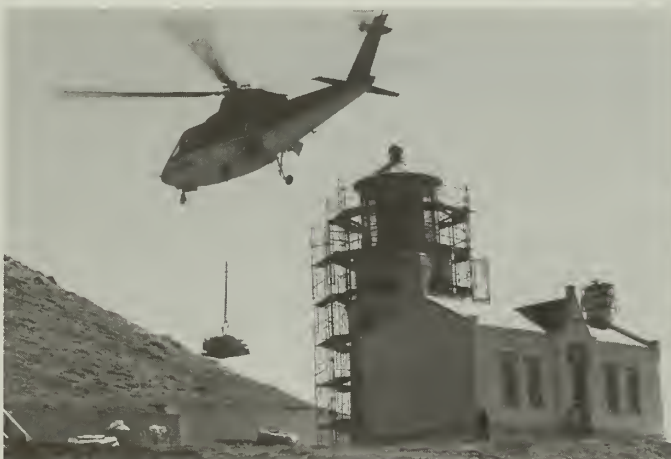
Figure 45. Staging the work. Note the temporary location of the auxiliary light on the fog signal building chimney.

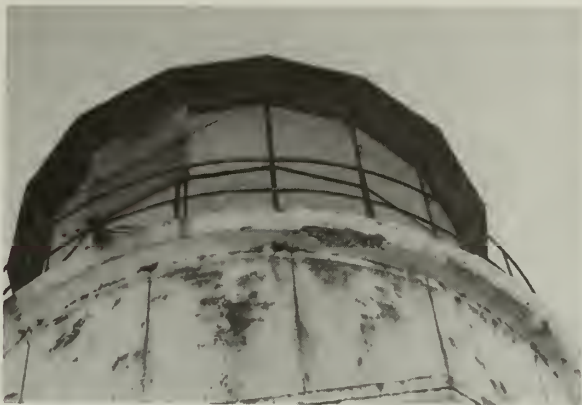
Figure 46. *Lighthouse lantern before rehabilitation.* Note the missing ladder rails and the severe rust on the lantern cornice and lower watch room panels. The badly spalled concrete gallery deck was installed in 1947 and is not original.

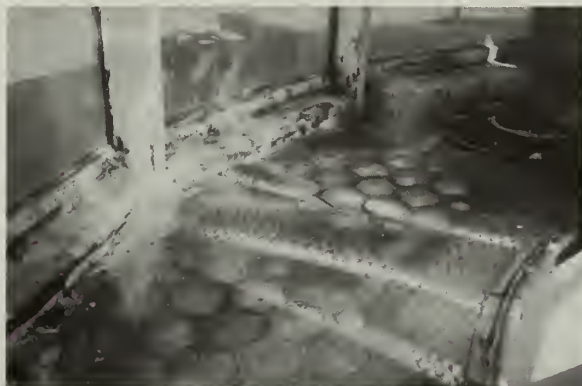
Figure 47. *Lantern room before rehabilitation.* Note the lower sill channels filled with concrete. This shortsighted 'repair' method blocked the ventilators and caused condensation to spill out on the deck, effecting rust and further damages below.

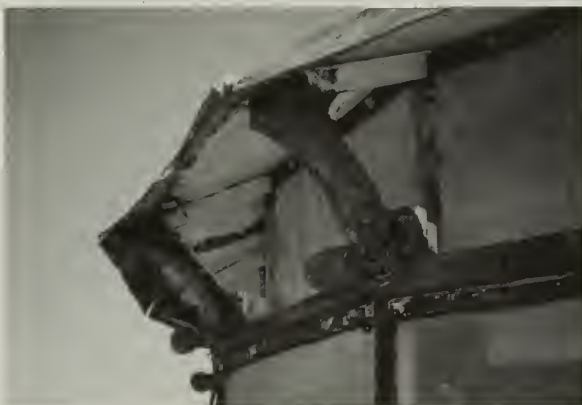
Figure 48. *Reconstructing the cornice.* The cornice plates were removed to expose the corroded cast-iron brackets and top channels. New brackets were cast in bronze, and the top sill channels were fabricated in stainless steel. Note the plywood 'curtain' erected for weather protection and shoring the lantern roof during reconstruction.

heavy rain washed out portions of the road, which cut off access for over a week. A special plywood 'curtain' was erected in the lantern room with clamps to protect the classical lens from the weather and shore up the lantern structure during reconstruction.

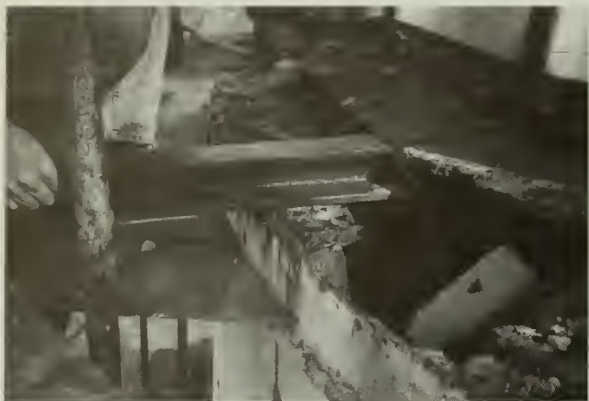
Figure 49. *Reconstructing the gallery deck.* After removing the existing concrete, remnants of the original cast-iron deck were found.

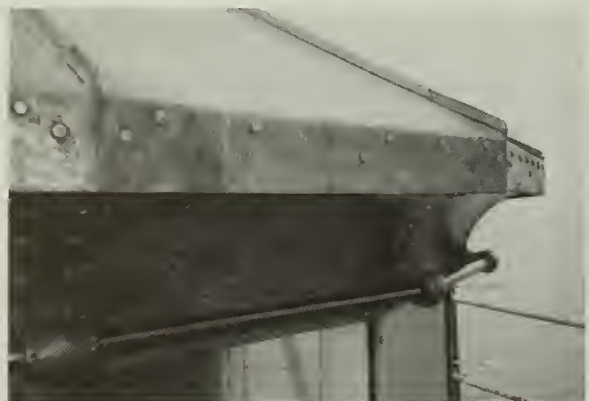
Figure 50. *Lantern cornice after rehabilitation.* Replacing the original steel cornice plates with copper eliminated the dissimilar metals problem.

Although surface rusting was the main problem at the lantern, some of the deterioration was caused by galvanic reaction between dissimilar metals. Dissimilar metal problems were eliminated by replacing the original deteriorated cast-iron cornice plates and brackets with copper and bronze. The original copper roof dome was then stripped of its paint and allowed to naturally patina. Besides low maintenance, the other advantages of copper are its flexibility to withstand strong winds, building movement, and wide temperature changes. In other areas, neoprene gaskets, felt or teflon tape, thick epoxy primers, and bituminous paints were used between dissimilar metals to prevent future corrosion.

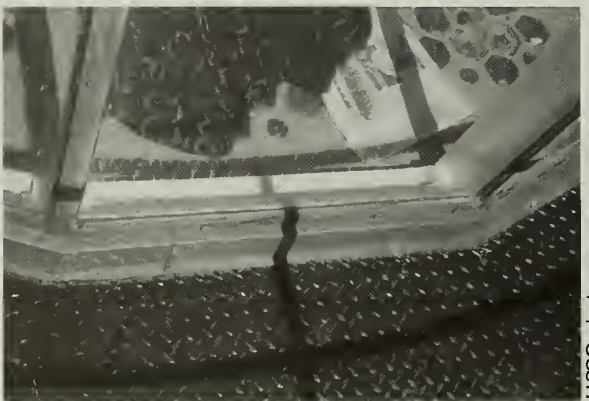
Figure 51. *Lantern galley deck after rehabilitation.* The new gallery deck was fabricated with stainless steel diamond plate and carefully flashed with copper at the lantern room. The interior lower sill channels were rebuilt to catch condensation from the glass.

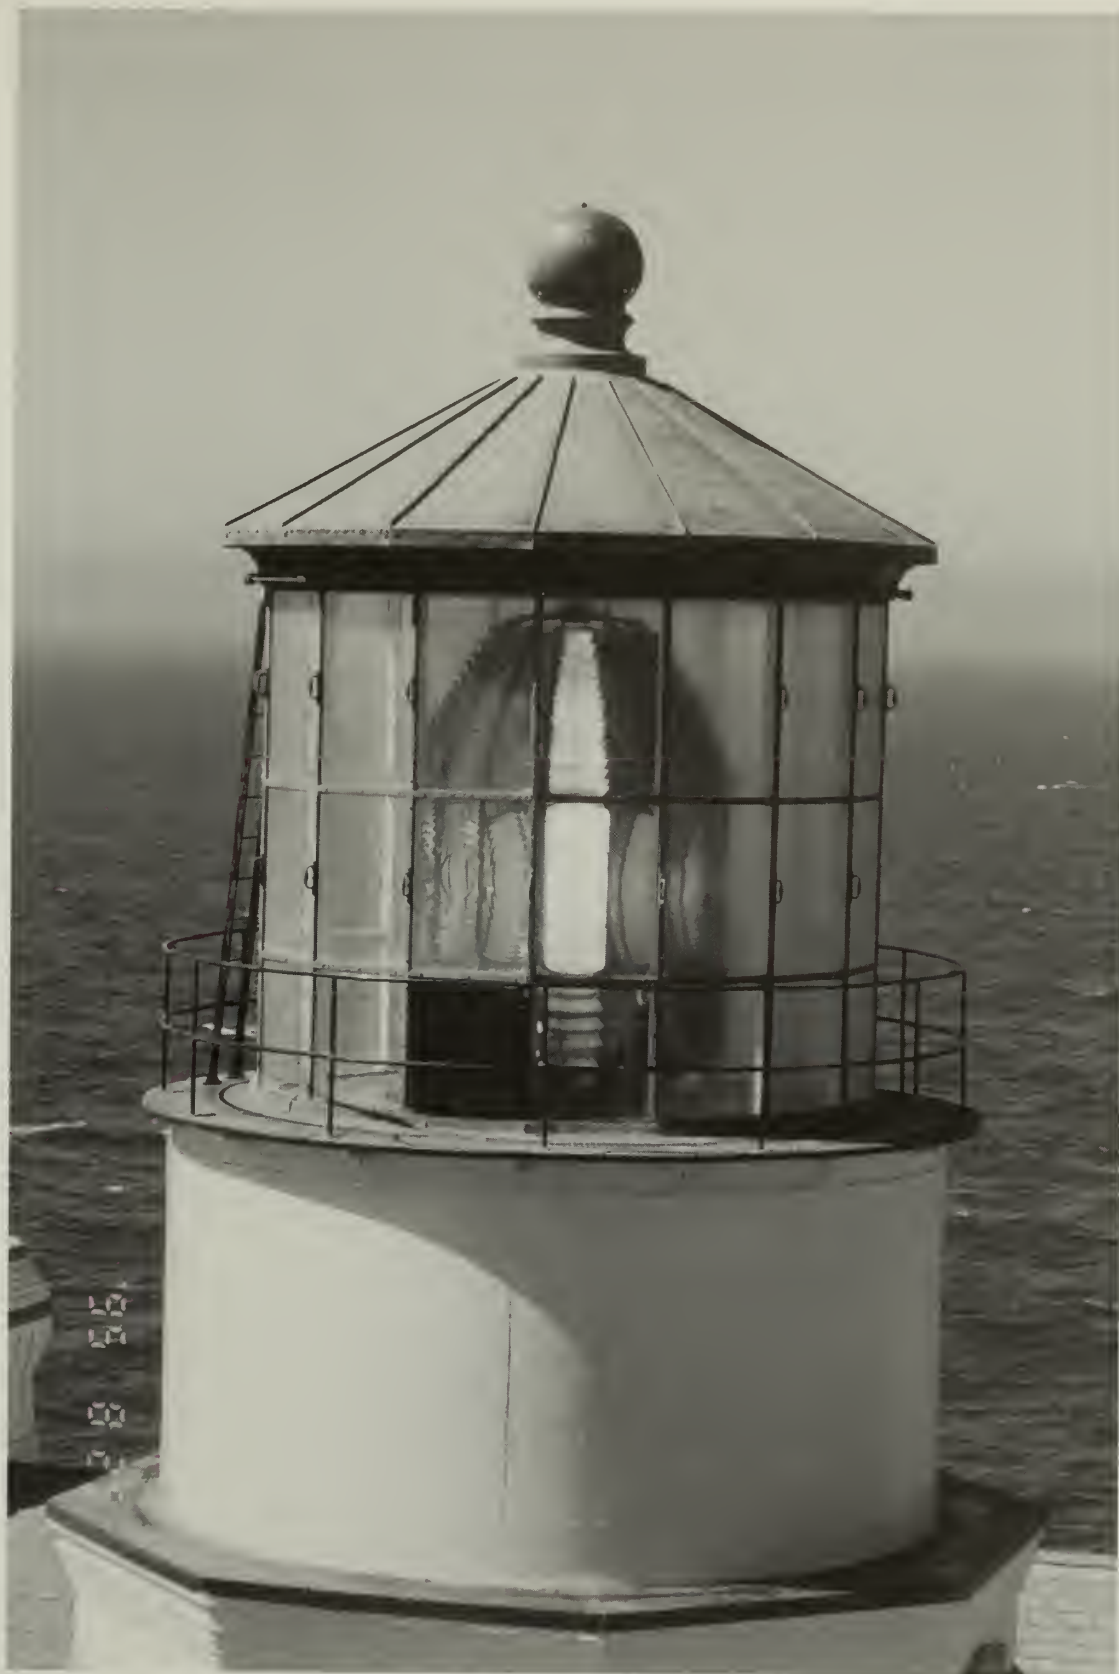
Figure 52. *Light tower lantern after rehabilitation.* The nonferrous metalwork at the lantern room is left unpainted and allowed to naturally patina, thus saving maintenance costs.

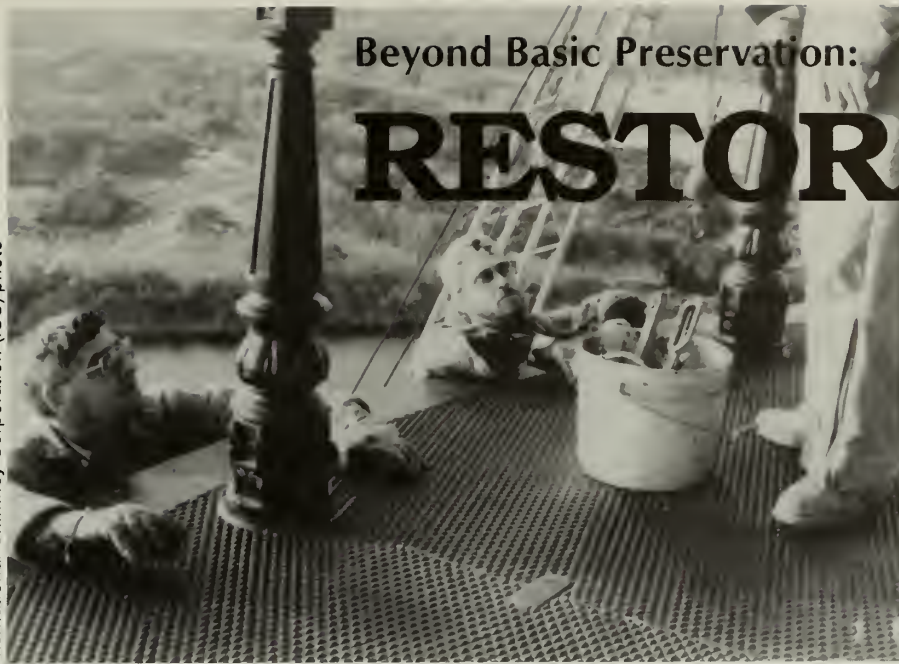
Figure 1. New ornate cast-iron handrail posts were recast and installed on the new gallery deck as part of a restoration at Cape Hatteras Lighthouse, Buxton, North Carolina.

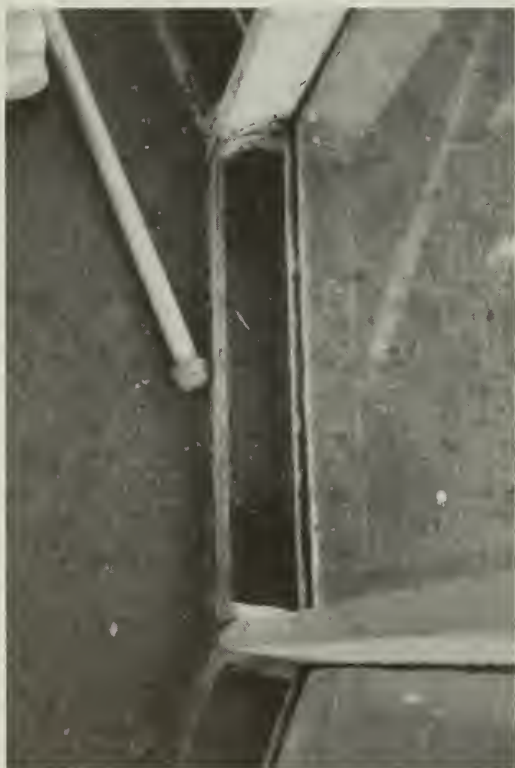
Figure 2 (left). Condition of the bronze sill sitting on the lantern deck inside the lantern room. The sill is wedged between two vertical cast-iron stiles, which are anchored into the masonry below.
